### Inspection Bulletin – LionC

| Bulletin | IB-0500_00_C - HVAC control panel wiring inspection |
| Coverage | Lion 360 (Diesel), LionC Gen3, Gen2 et Gen1 |

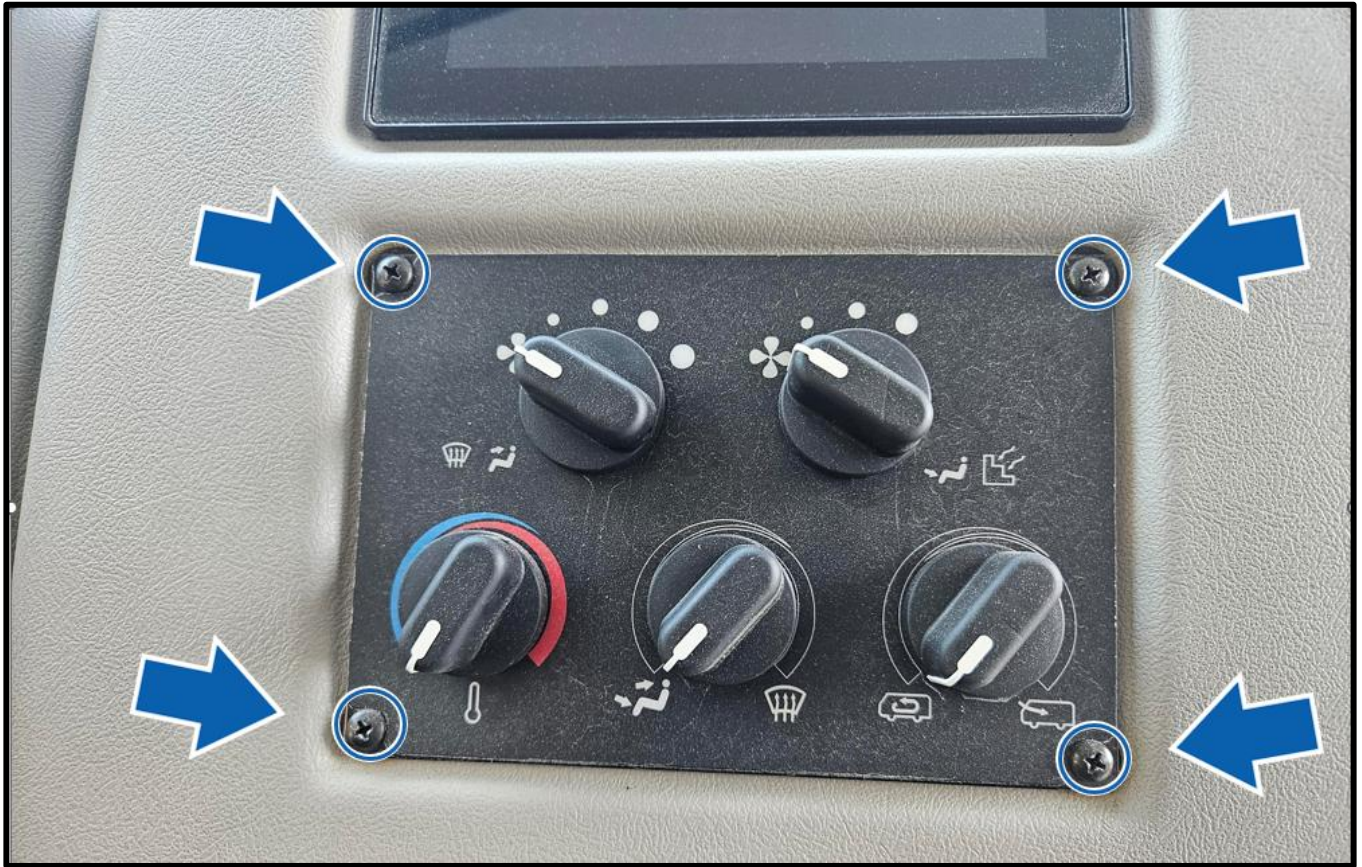
Figure 1 – Heater Control Panel fasteners

- 1-A** Remove the four screws securing the HVAC control panel to the center console.

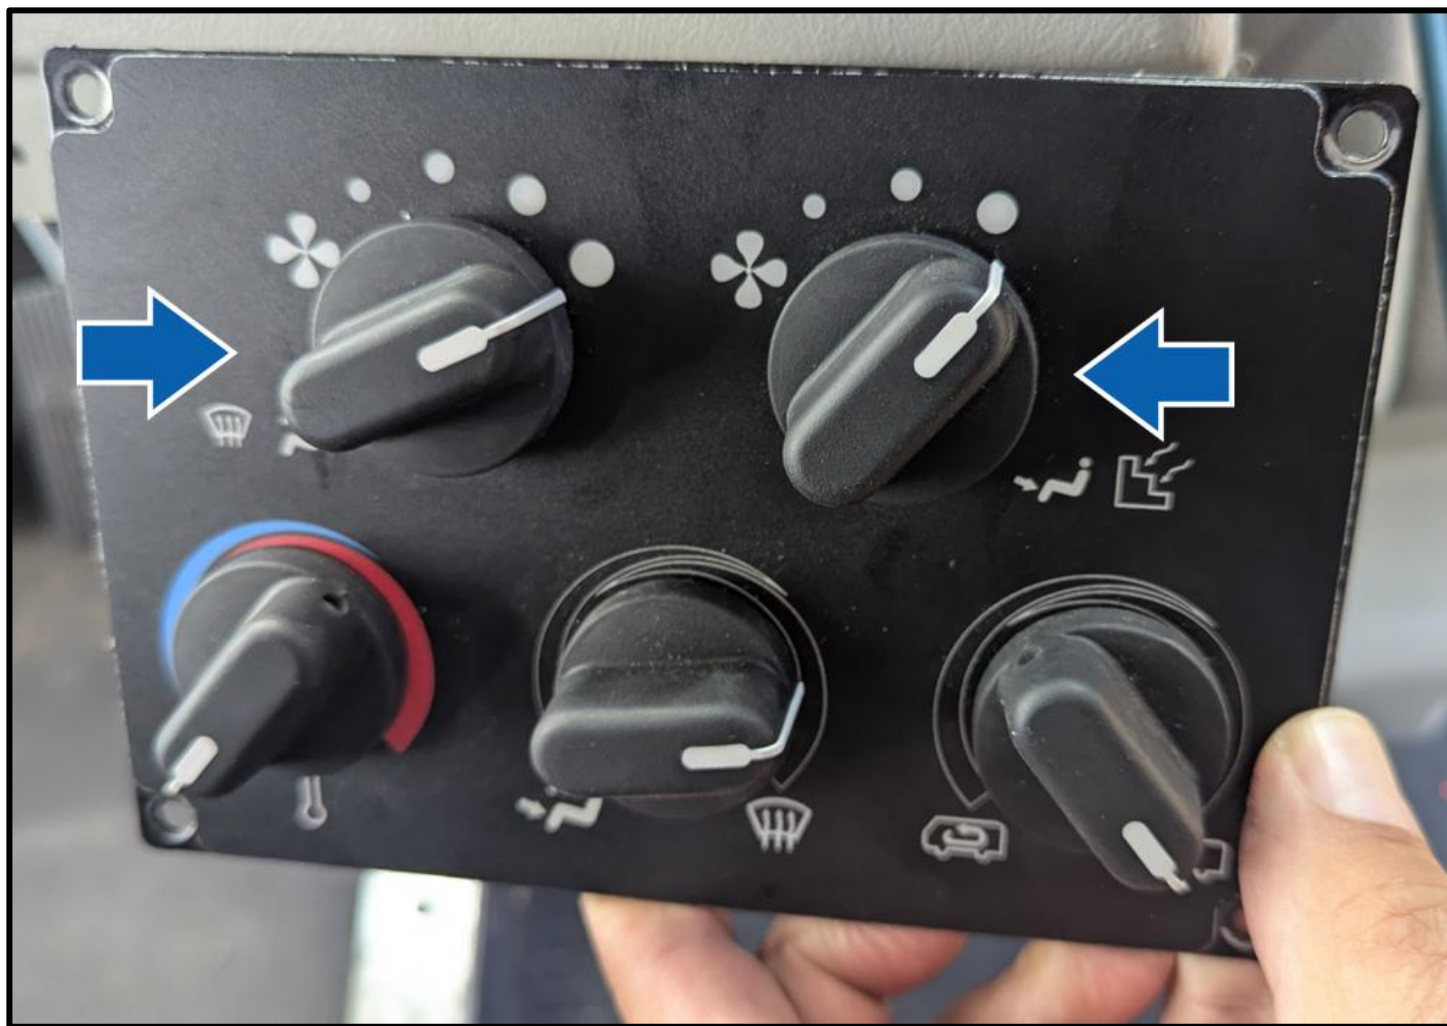
Figure 4 – Fan switches.

Pay attention to the male spades behind the two fan switches (Figure 4). All male terminals must be in good condition and securely fastened behind the switches. None of the rivets (Figure 5) securing the terminals should be loose or detached.

If any connector, terminal or rivet is faulty, replace them.

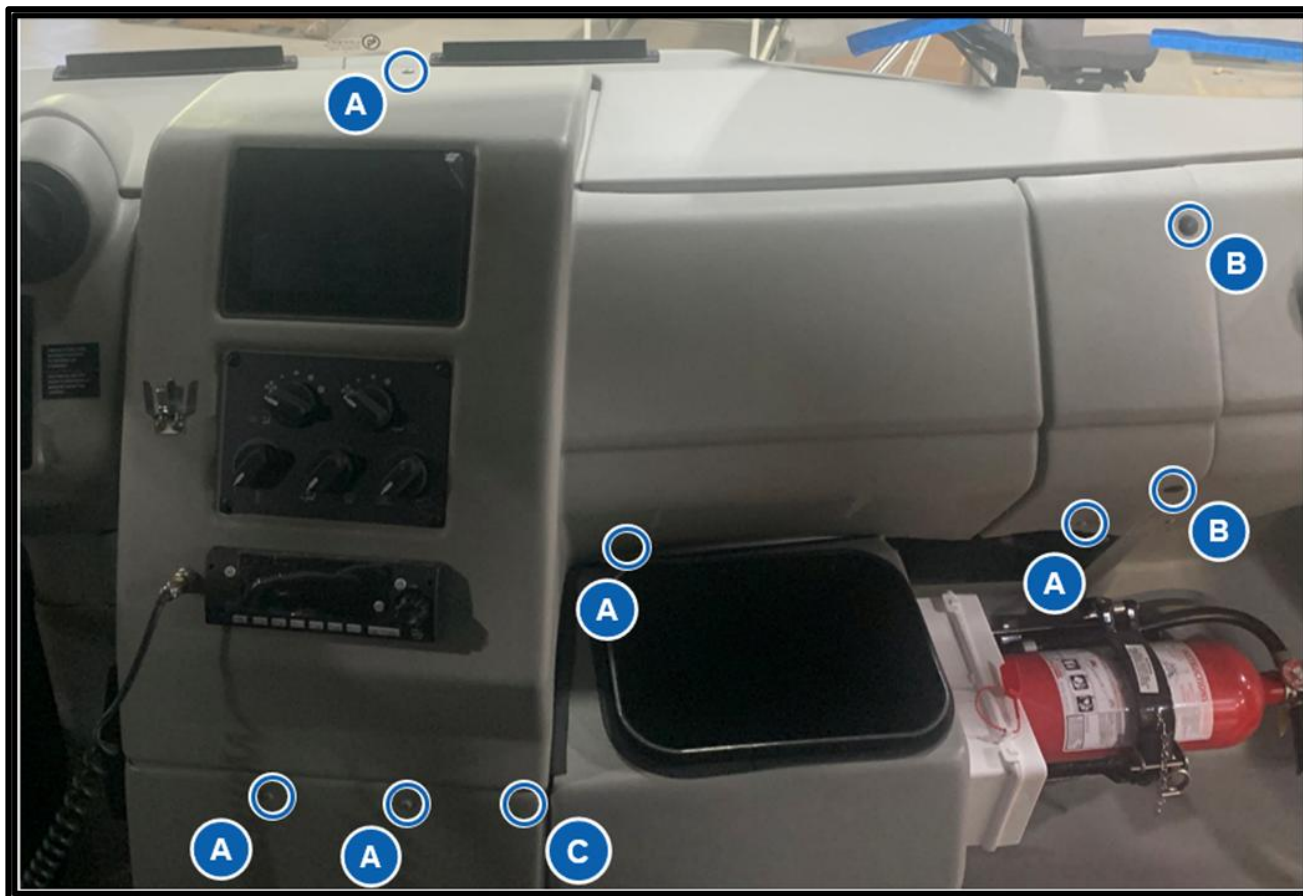
Figure 6 – Center console fasteners

Remove the panel to the right of the trash bin. Remove 5 screws (A), 2 pins (B) and an additional screw (C) hidden behind the lower panel to detach the center console from the dashboard.

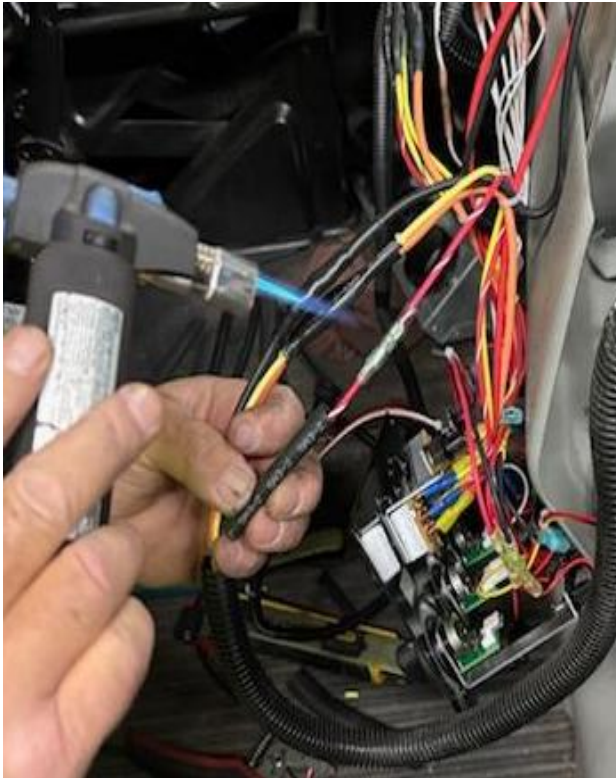
*Figure 9 – Solder filled butt connectors and heat-shrink tubing.*

Cut the wires of the connectors to be removed. Connect the wires using solder-filled butt connectors.

Note: It is recommended to cover connectors with shrink tubing.

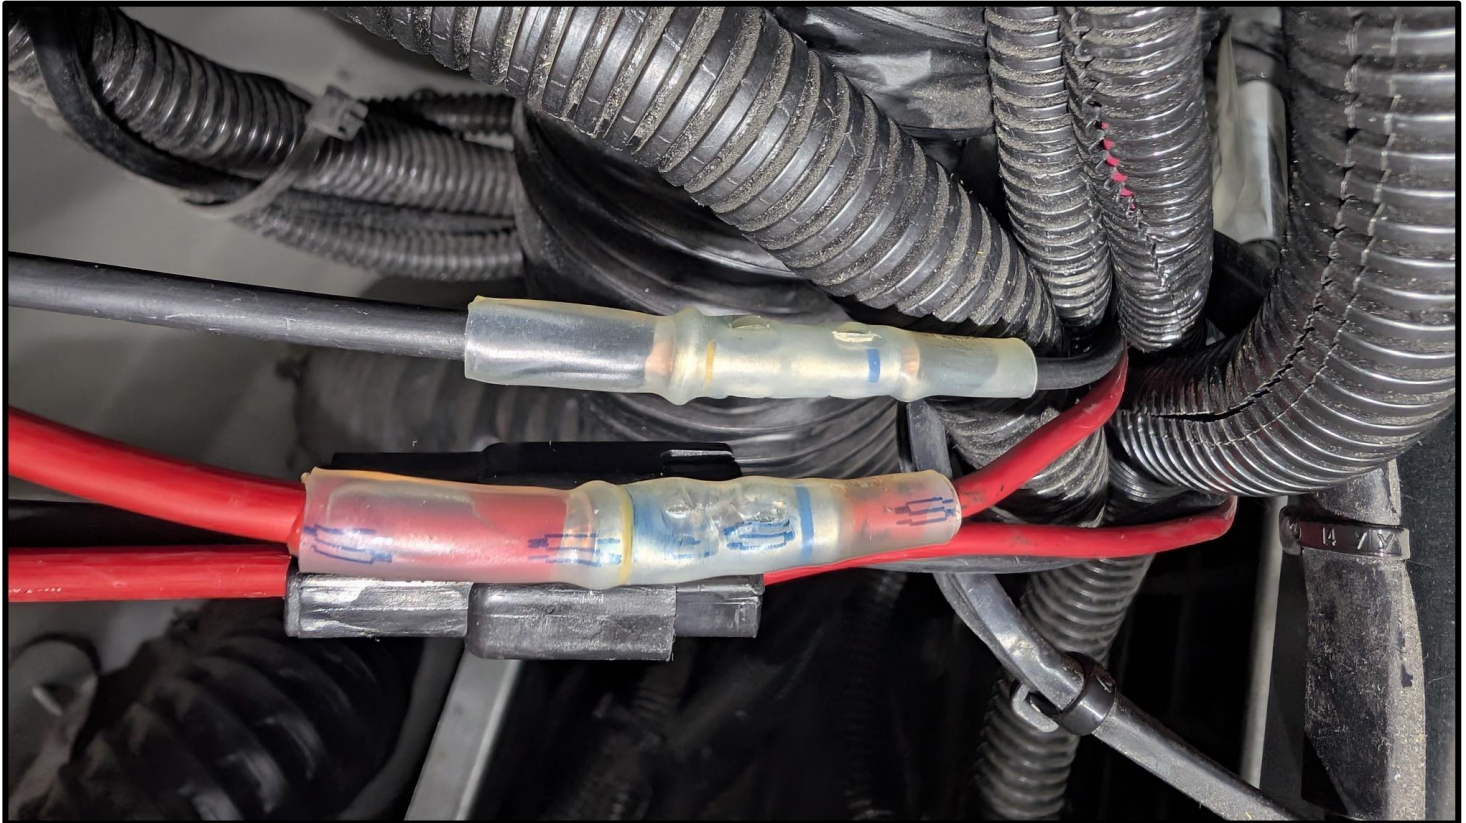
Figure 10 – Double size butt splice connectors.

Beware, some connectors have wires of different sizes on either side of the connector. Connect the wires with butt splices of the appropriate size (yellow line on one side, blue on the other) for the two wires to be connected.

Note: It is recommended to cover all butt splices with shrink tubing.

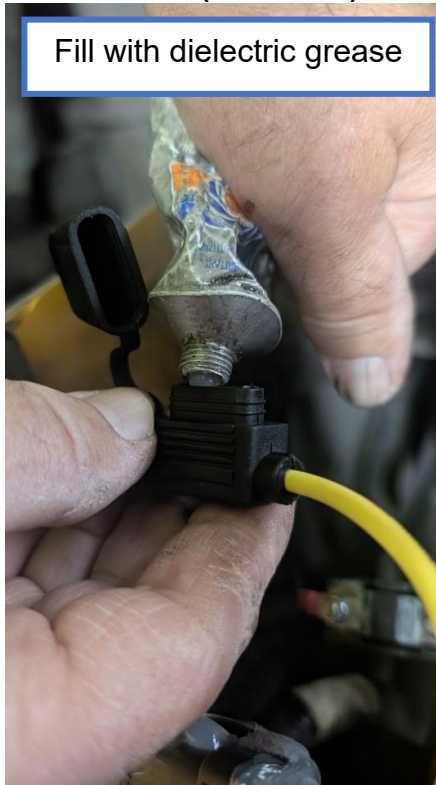
*Figure 13 –Fuse to replace.*

There are two types of fuse box on the left front fender (near the steering column) which include a fuse for the defroster fan.

If the bus is equipped with a fuse box with a cover, replace the existing fuse by a 25A fuse.

If the bus is equipped with MIDI fuses (under a red rubber cover), locate the 40A fan fuse (in-line fuse, label HVAC PWR) and replace it by a 25A in-line fuse. There are 2 possible methods to install the 25A fuse.

Fill with dielectric grease

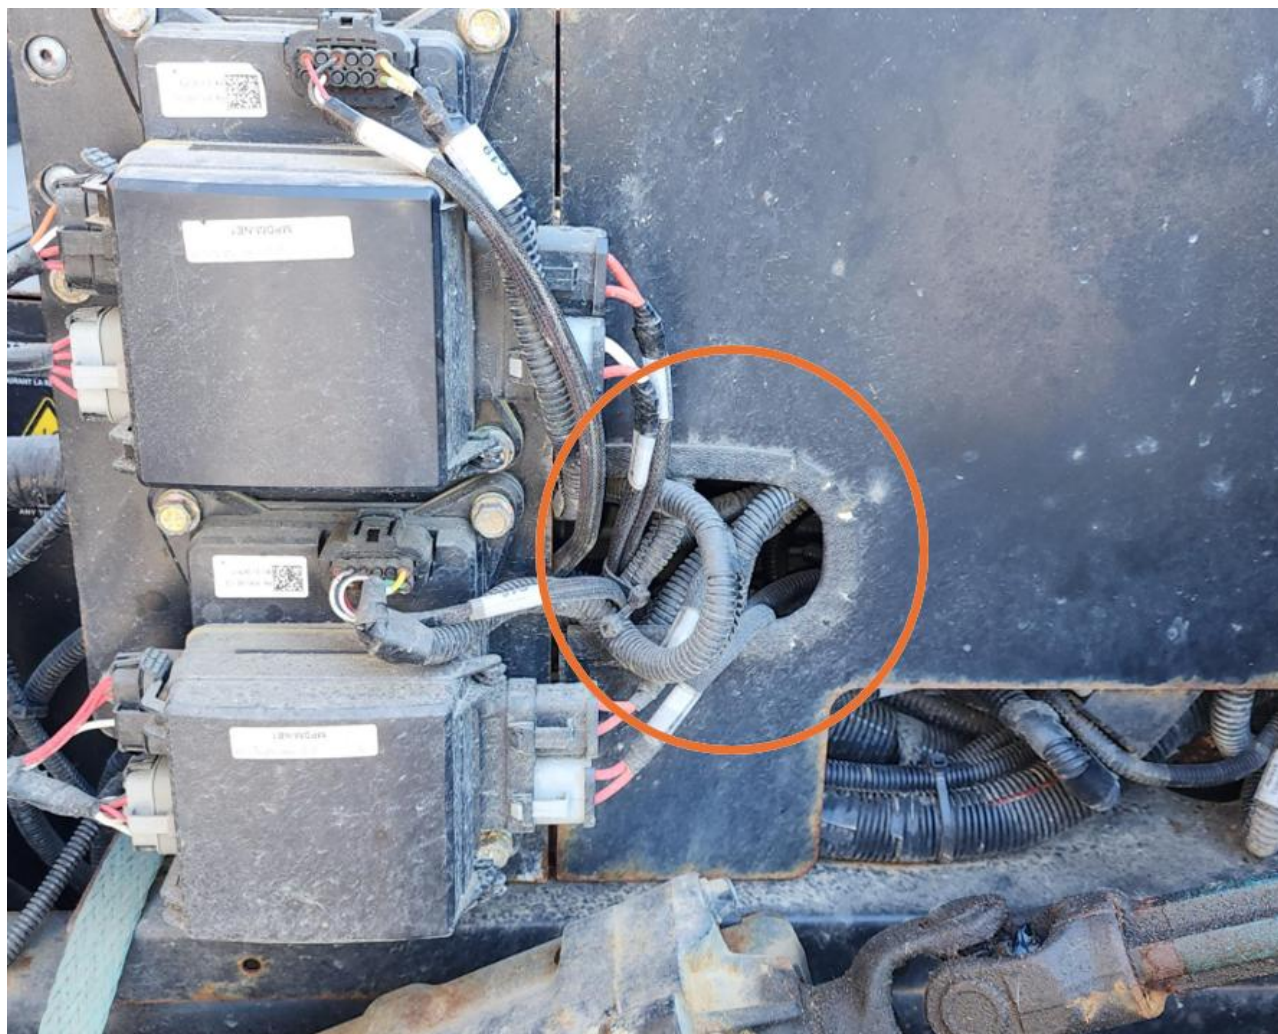
*Figure 16 – Accessory plate wiring.*

With the hood open, check the condition of the wiring which passes through the opening at the bottom left of the accessory plate. It must not be damaged by abrasion or under tension.

If this is the case, repair the damaged section of wiring and rectify the cause.

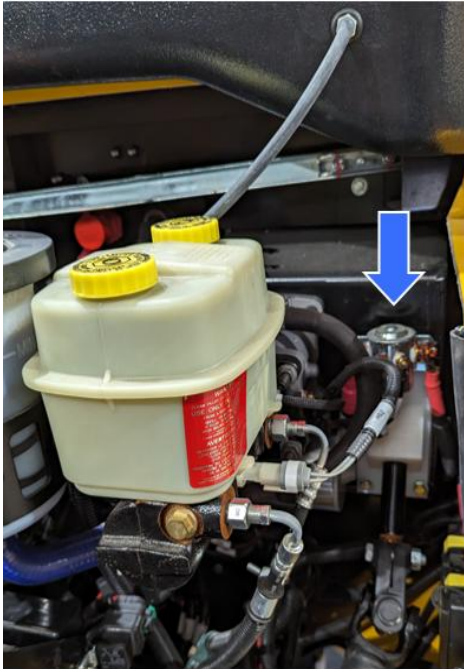
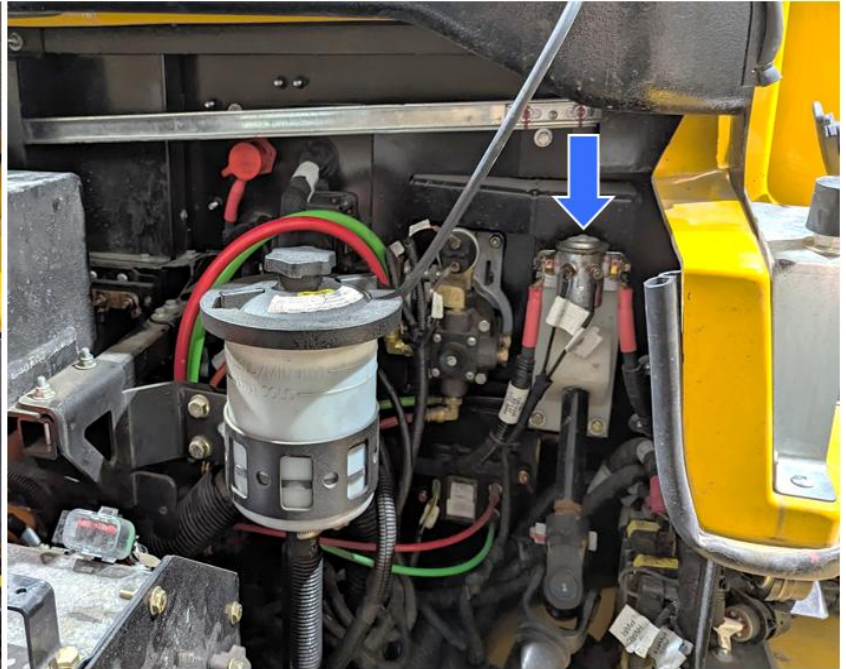
Figure 18 – Start solenoid location

Under the hood, locate the start solenoid attached to the firewall near the steering column.

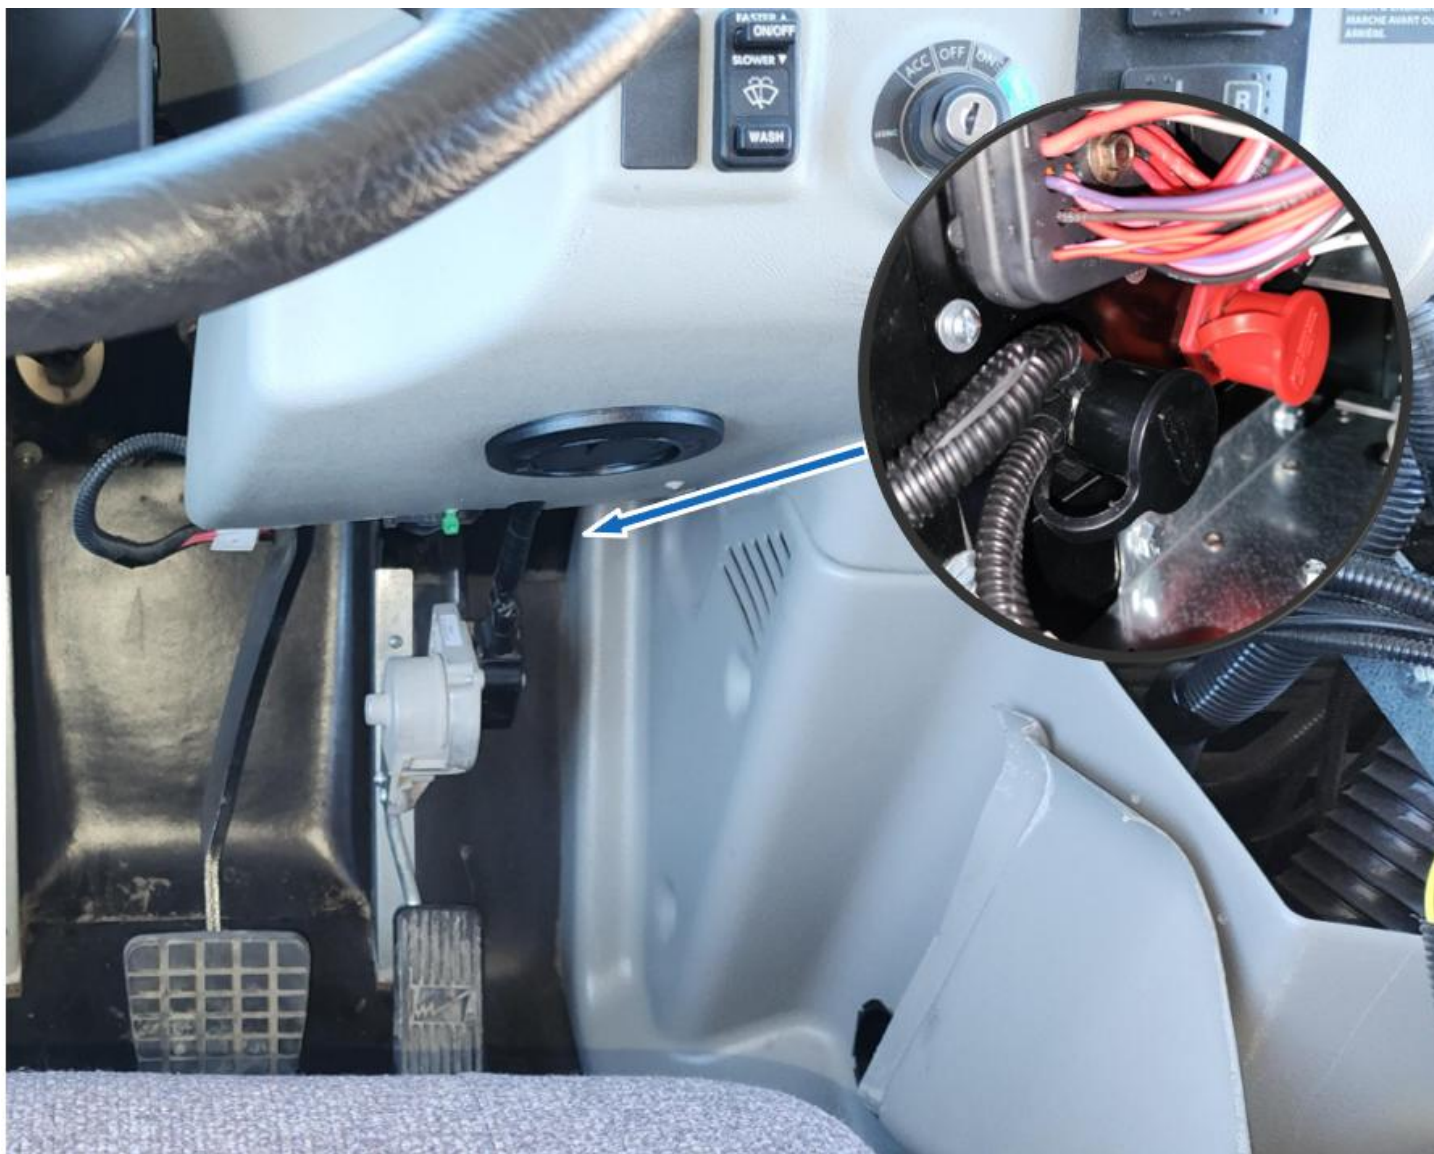
Figure 22 – Location of the passthrough studs

To check the bulkhead passthrough terminals inside the bus, go through the opening on the right-hand side of the gas pedal. The two bulkhead studs are visible and accessible. You can also remove the lower part of the center console to gain easier access.

If either terminal is loose, perform Service Bulletin TB-0365\_00\_A.

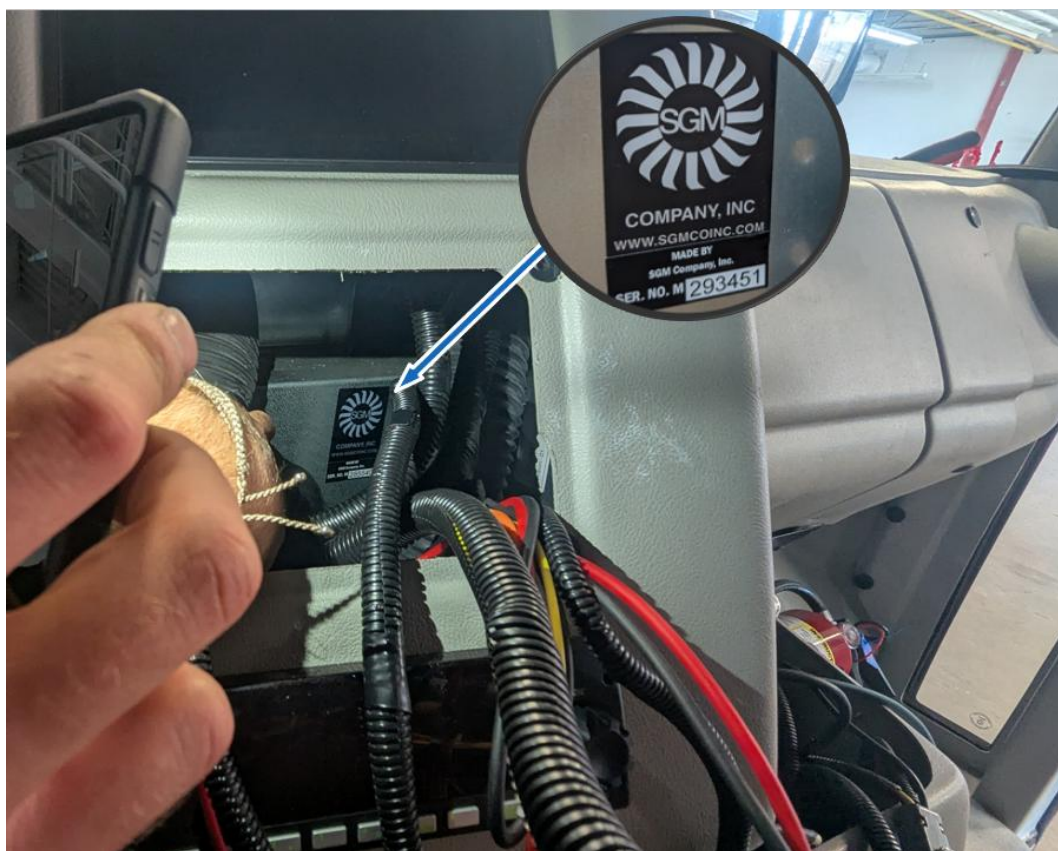
Figure 23 – Serial number of the HVAC unit

- a detailed description of the problem(s) detected
- a photo or video of the fault(s)
- the serial number of the HVAC unit (see next figure).

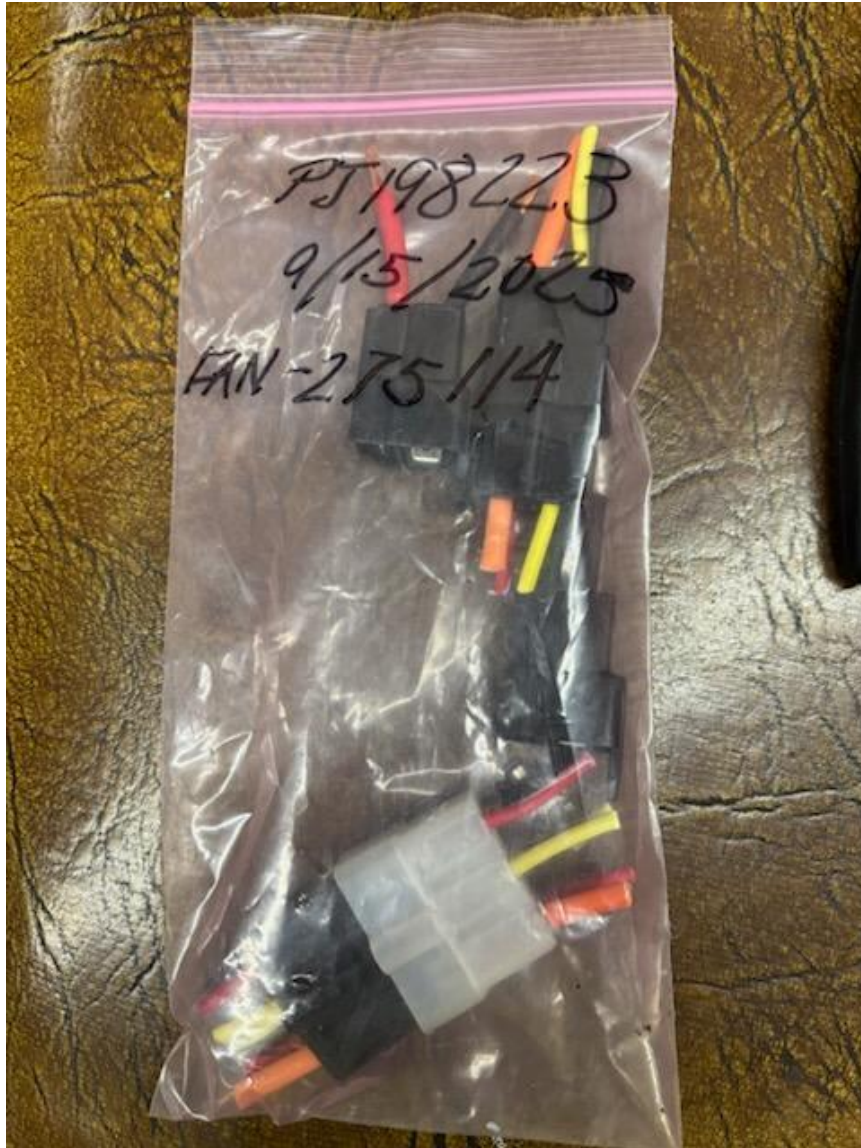
Figure 24: Parts to be returned to Lion

Connectors that have been discarded should be returned to Lion for analysis.
